BIOREACTOR PERFORMANCE SUMMARY

TO: CHRIS HENNING
FROM: ALEX BUSEMAN
SUBJECT: BIOREACTOR MONITORING AND PERFORMANCE SUMMARY
DATE: 11/11/2024
CC: ROGER WOLF, TODD SUTPHIN, TONY SEEMAN, ETHAN WING

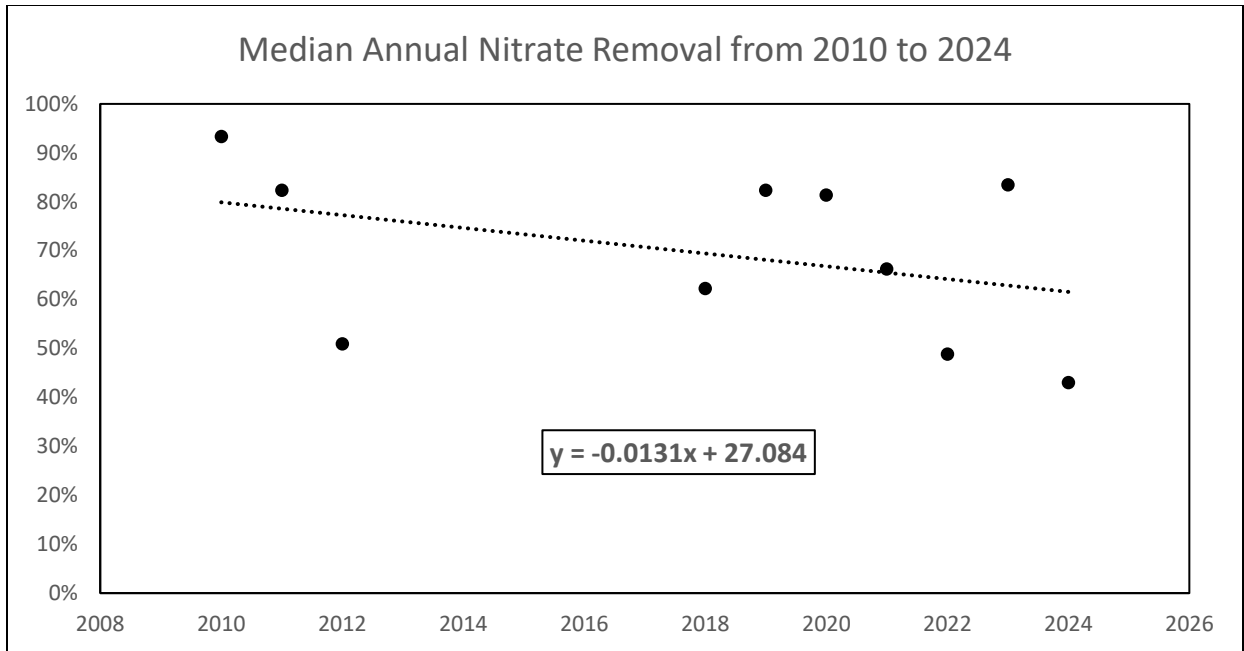
From 2010 to 2024, nitrate removal ranged from 11.88 to 98.32% and averaged 64.94% (median = 72.00%). The median annual nitrate removal observed from each sample year shows us how the nitrate removal performance has changed over time (Figure 1). In 2024, the average nitrate removal was 50.70% and the median was 43.02%. This is within range of average bioreactor performances in Iowa which is exceptionally good for this bioreactor's age. When bioreactors get more than a decade old, it is important to assess flow-weighted nitrate removal because a bioreactor's performance is influenced by its ability to conduct flow through the chamber. In 2024, this was measured to be 0.38 pounds of nitrate per day on average. This rate is below average and could signify that flow is becoming restricted and slowing down inside the chamber. This phenomenon is not uncommon for bioreactors at this age.

Figure 1. Median annual nitrate removal from 2010 to 2024.

The 2010 bioreactor has shown consistent removal efficiency in nitrate removal over time. Recent observations of inadequate flow-weighted nitrate removal could mean that flow is being restricted inside the chamber. The subsidence, which is the surface area above the chamber sinking, is also observed at this site which increases the chance of flow restrictions. Subsidence is a common occurrence for all bioreactors, especially at extended ages. When it occurs, it just means that your bioreactor might be ready for a woodchip recharge. A woodchip recharge essentially resets the lifespan of the bioreactor by replacing the aged woodchips with a fresh batch. Although a recharge does not seem necessary now, one may be within the next couple of years. The best way to know if a recharge is needed is by checking the site after a heavy rain. If there is water bypassing at the inlet structure, but no flow at the outlet structure, it means that the bioreactor's flow is fully restricted, and a recharge is needed. ISA would be happy to help with any technical assistance and monitor the bioreactor as it continues to age. When a recharge is necessary, we can connect you with existing NRCS funding opportunities to pay for it.
